Blunt Impact Damage of Composite Fuselage Structures

Hyonny Kim*, Gabriela DeFrancisci, and Zhi Chen

Department of Structural Engineering, University of California San Diego
La Jolla, CA 92093, USA

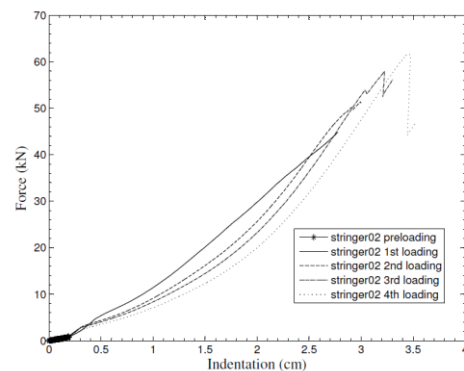
Figure 1: Load vs. displacement of the stiffened panel indented with the OEM rubber bumper

construction. These specimens were indented quasi-statically, at two locations relative to the stringers (hat stiffeners), with rigid impactors of different geometries, as well as with a hard-rubber beltloader bumper, in order to determine how impactor "bluntness" relates to damage formation and visual detectability. Panels indented with a 76.2 mm radius aluminum impactor resulted in penetration through the skin with no debonding of the stringers. Failure occurred at a load of 30.68 kN when indented directly centered over the stringer, and at 26.43 kN when indented between stringers. The panel indented with the rubber bumper developed significant debonding between the stringers and skin, with no visible damage to the exterior surface at much higher load levels, up to 61.65 kN, at which point major stringer debonding occurred. The load progression of the panel indented with the OEM bumper between stringers is shown in Figure 1. The specimen indented with the bumper also experienced more widespread internal damage in structural components away from the location of impact.
